SUBMISSION TO THE SENATE REFERENCES COMMITTEE
RURAL AND REGIONAL AFFAIRS AND TRANSPORT

AIR SAFETY – BAE 146
CABIN AIR QUALITY

**EXAMINATION OF AIR SAFETY WITH REFERENCE TO AIR QUALITY OF BAE 146
AIRCRAFT.**

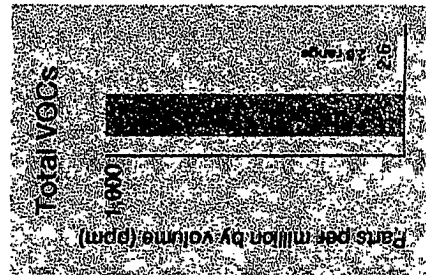
Comparison of Airplane Air Quality Test Results to Existing Standards

Note: Graphs represent the highest airplane cabin measurement values in flight from listed studies.
